DEPARTMENT OF TRANSPORTATION

Quality Assurance and Source Inspection

Contract #: 04-0120F4Cty: SF/ALA Rte: 80 PM: 13.2/13.9File #: 69.28**WELDING INSPECTION REPORT****Resident Engineer:** Pursell, Gary**Address:** 333 Burma Road**City:** Oakland, CA 94607**Report No:** WIR-003576**Date Inspected:** 04-Aug-2008**Project Name:** SAS Superstructure**OSM Arrival Time:** 1400**Prime Contractor:** American Bridge/Fluor Enterprises, a JV**OSM Departure Time:** 2330**Contractor:** Zhenhua Port Machinery Company, Ltd (ZPMC), Changxing Island **Location:** Shanghai, China**CWI Name:** Li Yan Hua**CWI Present:** Yes No**Inspected CWI report:** Yes No N/A**Rod Oven in Use:** Yes No N/A**Electrode to specification:** Yes No N/A**Weld Procedures Followed:** Yes No N/A**Qualified Welders:** Yes No N/A**Verified Joint Fit-up:** Yes No N/A**Approved Drawings:** Yes No N/A**Approved WPS:** Yes No N/A**Delayed / Cancelled:** Yes No N/A**Bridge No:** 34-0006**Component:** OBG/Tower**Summary of Items Observed:**

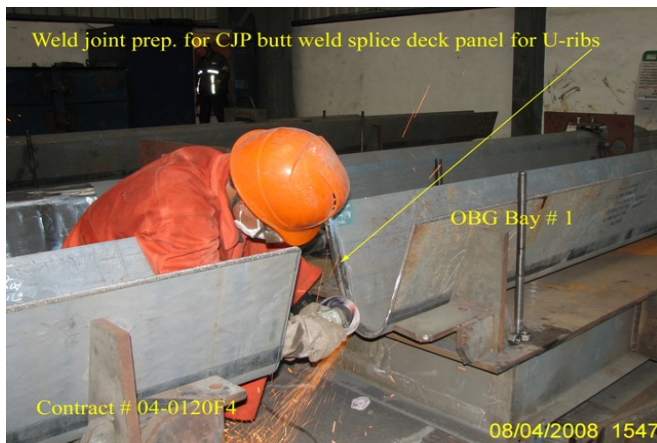
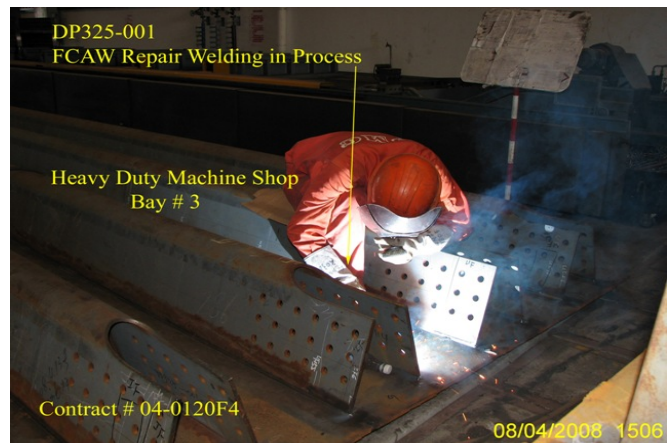
The QA Inspector observed tack weld grinding in progress on DP576-001 by ZPMC personnel at Gantry #1, after the grinding of tack welds ZPMC Magnetic Particle Technician Cai Xin Xin performed MT testing and found 3 longitudinal cracks ranging in length from 3 to 7 millimeters, the cracks were removed by further grinding.

The QA Inspector observed Submerged Arc Welding (SAW) being performed at Gantry # 2 on DP360-001, after the welding was completed the QA Inspector observed weld # 10 U-rib 335 had approximately 1000mm of incomplete fusion.

The QA Inspector noticed the welder starting to grind the (IF) location and the ZPMC CWI Inspector Li Yan Hua was informed by the QA Inspector that the deck panel had not received a 3 party initial visual inspection for repair

welding identification. The CWI decided to stop the welding and have the deck panel scheduled to be repaired at the Heavy duty Tower Repair Shop.
